Technical Report ARAED-TR-96002

**METALLURGICAL ANALYSIS OF AN ALUMINUM SABOT FIRED
IN THE CANNON CALIBER ELECTROMAGNETIC GUN (CCEMG)**

Stacey Clark Kerwien

June 1996

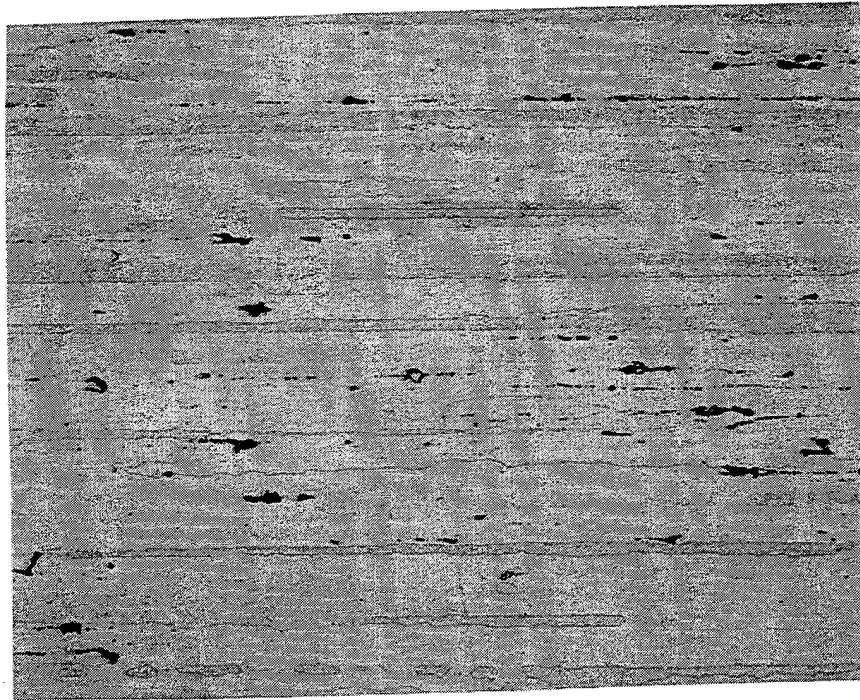
Figure 3
Microstructure of aluminum 7475 (200X)

For purposes of comparison, a typical microstructure of forged Al-7475 is shown in figure 3. Here, elongated aluminum grains with insoluble particles and second phase particles of magnesium and silicon are seen.
